Lead Risk Assessment Report

For the property at:

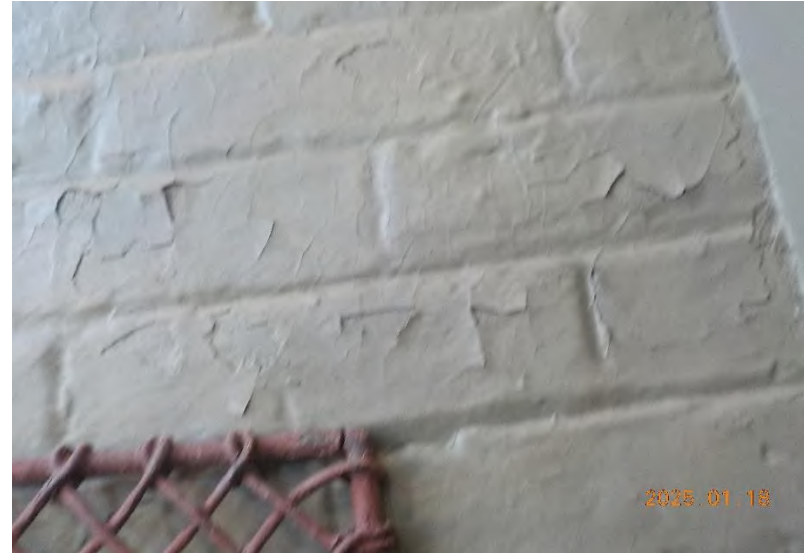
Walls A (north) & C (south) of East Lobby have blistered/peeling paint.

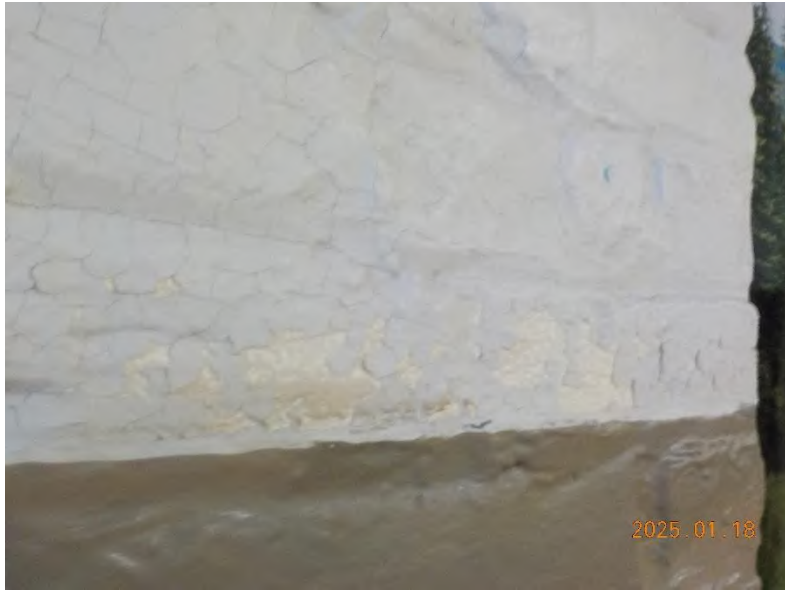
Teacher's Lounge – wall A (north) – spiderweb cracking/flaking

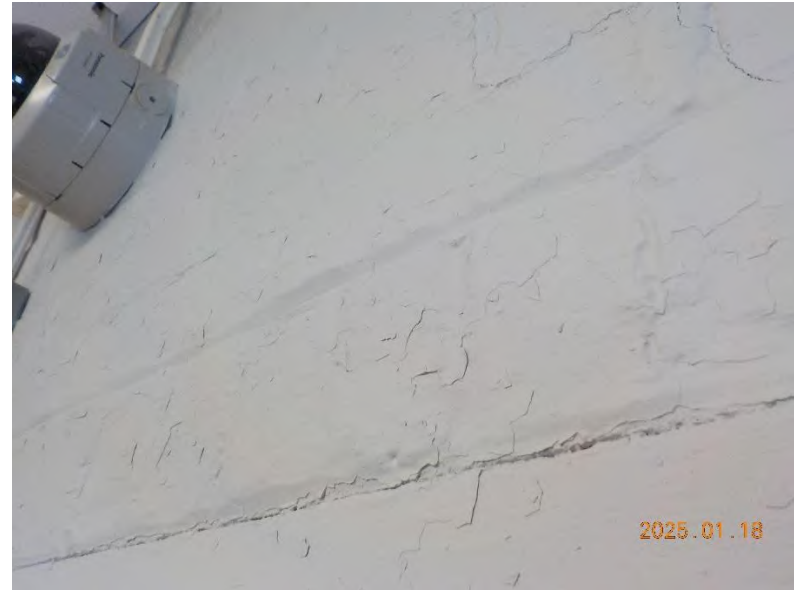
Teacher's lounge – wall B (east) – spiderweb cracking

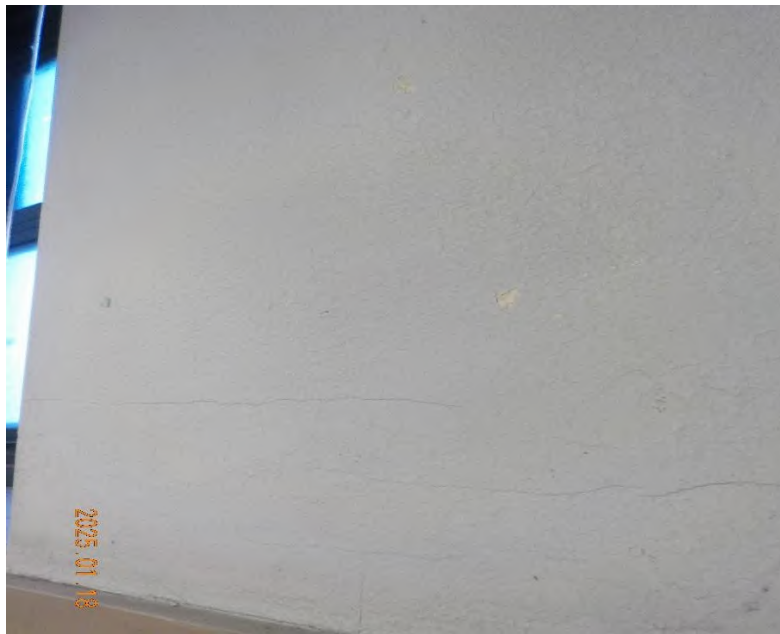
Teacher's Lounge – wall D (west)/spiderweb cracking/minor chipping

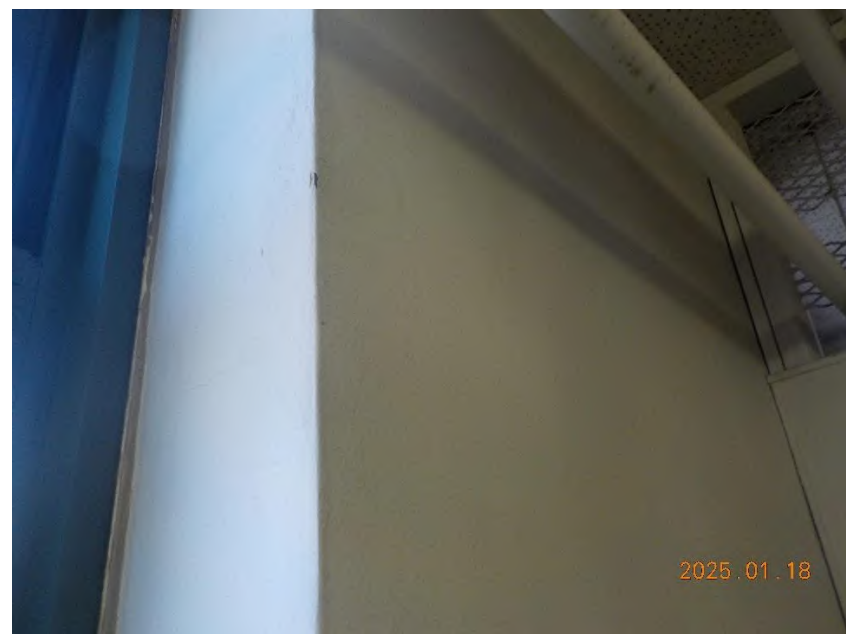
Kitchen Receiving – wall D – spiderweb cracking/minimal chips

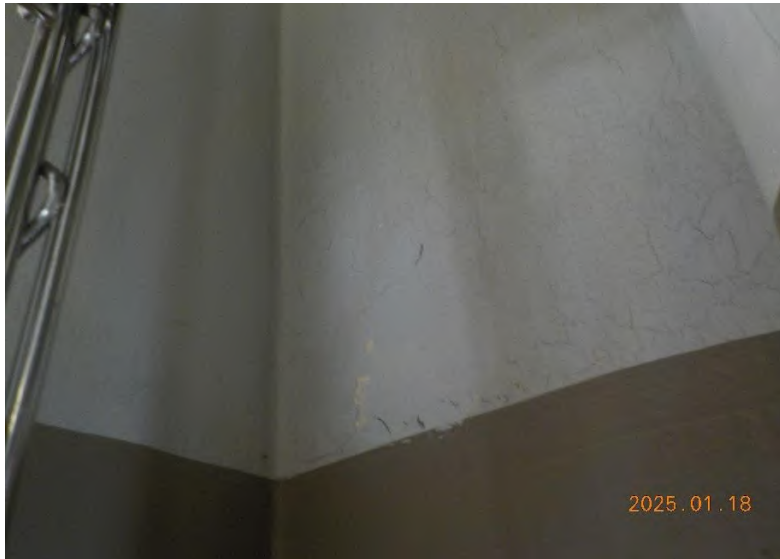
Kitchen Receiving – wall C (south) – spiderweb cracks/minor chipping

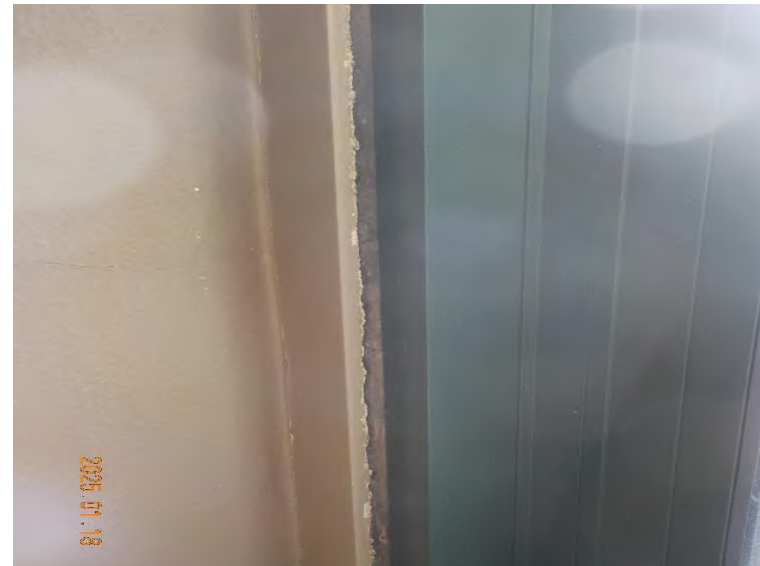
Example of original window casement(trim) in Kitchen Receiving along walls C & D - Shown #25 – pickable/cracked paint

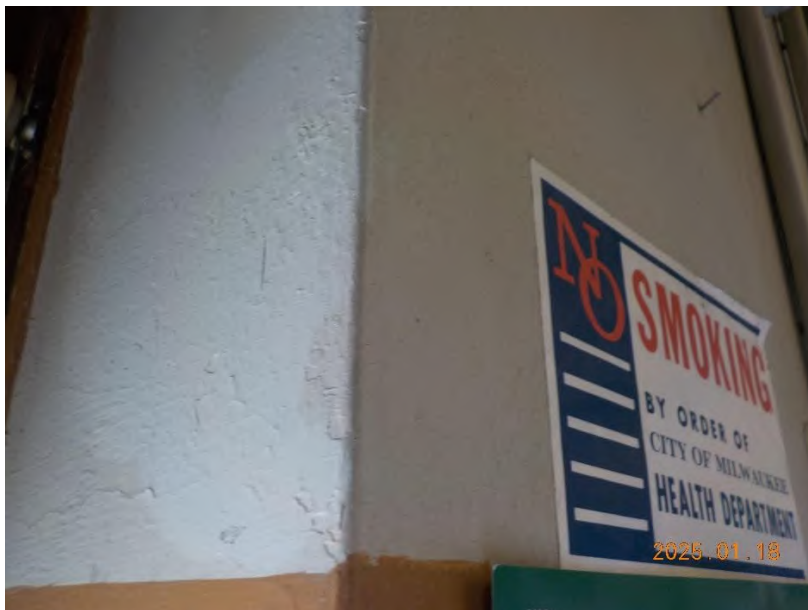
Kitchen – wall C (south) – spiderweb cracking/chipped paint

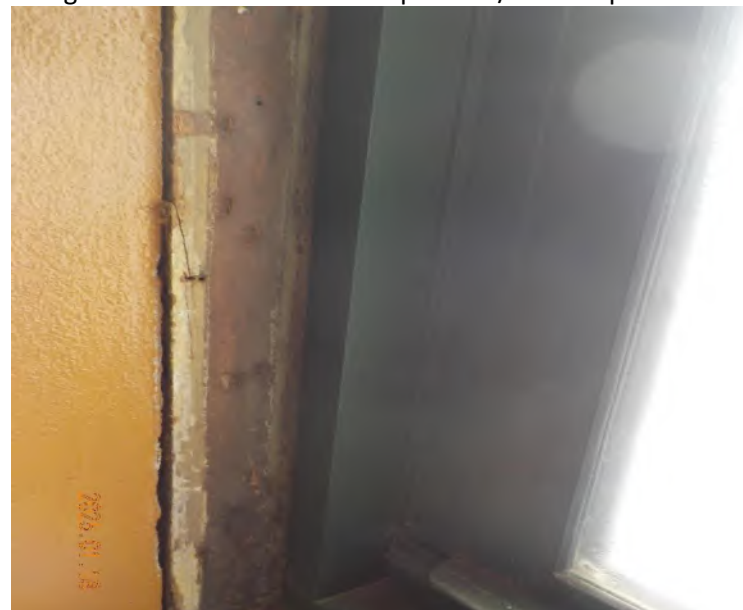
Example of original window casement in Kitchen Shown #24 – pickable/cracked paint

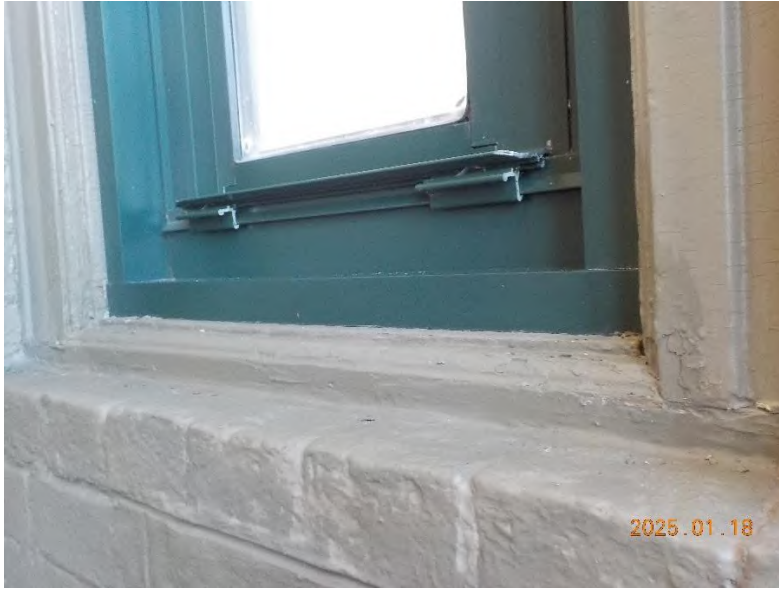
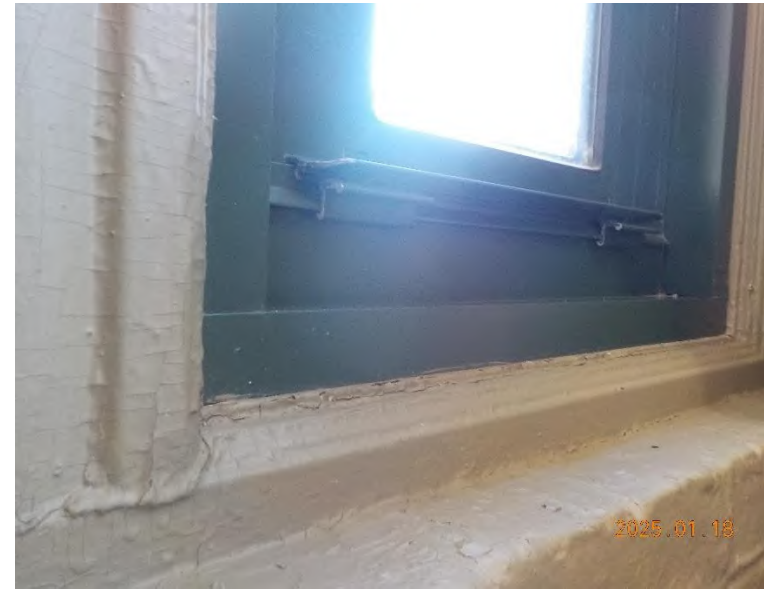
East Lobby – windows #16 and 17 (left to right) along wall A (north) – spiderweb cracking will continue to deteriorate, monitor closely

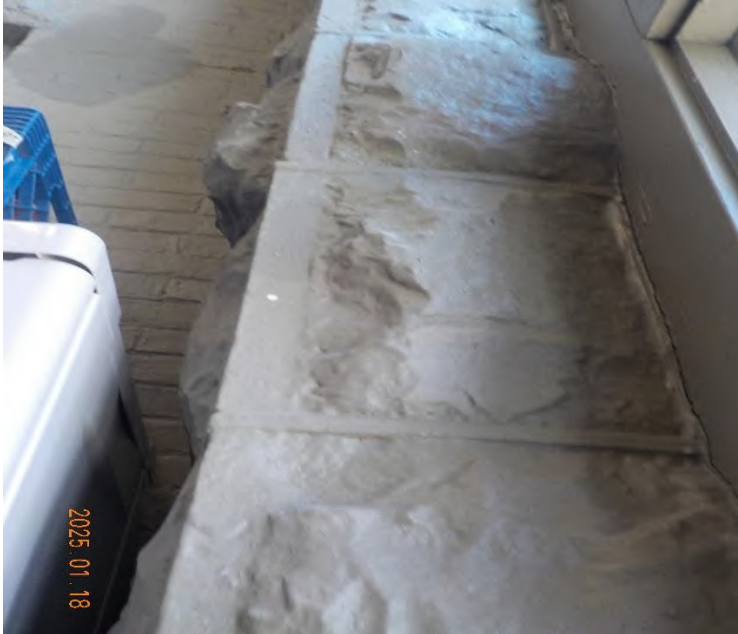
Stone masonry column north (left) of exterior doors inside East Lobby – blistered paint that chips easily if touched

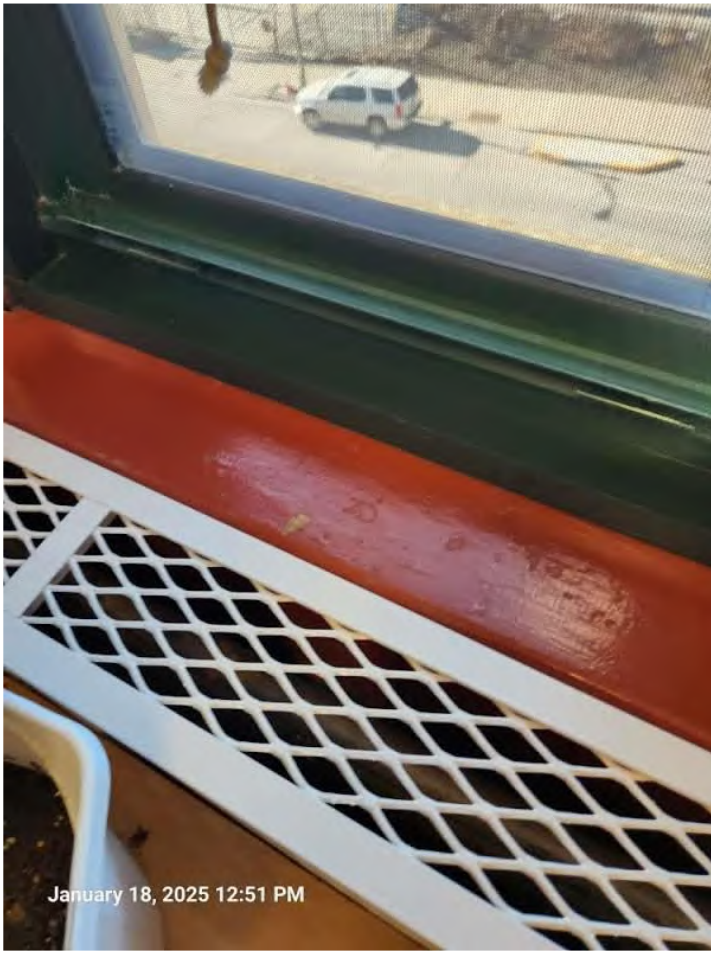
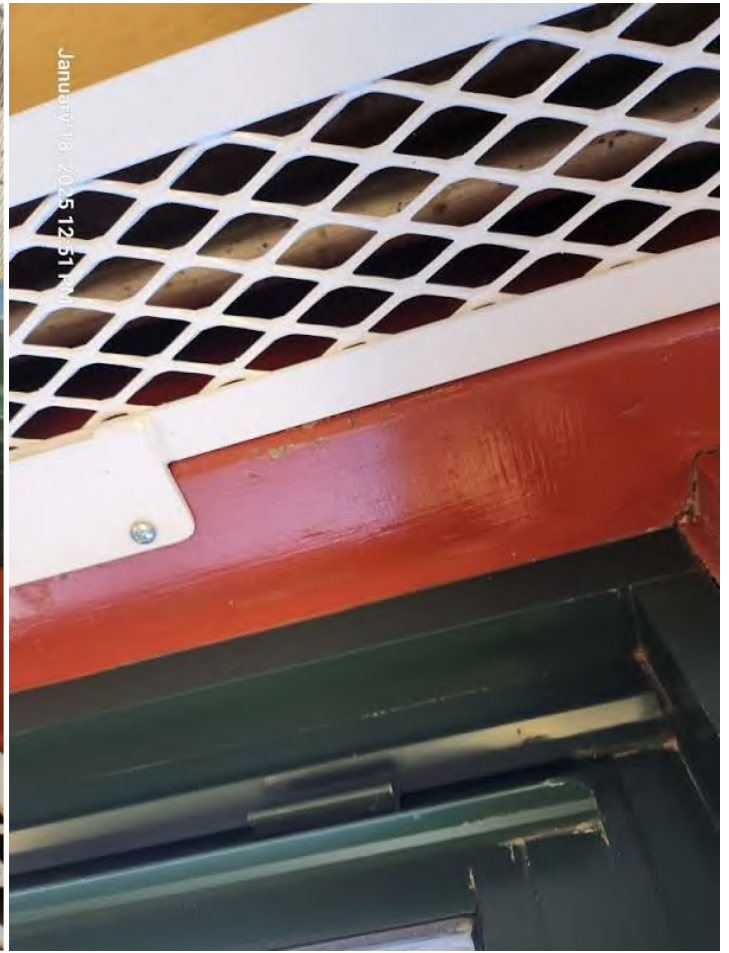
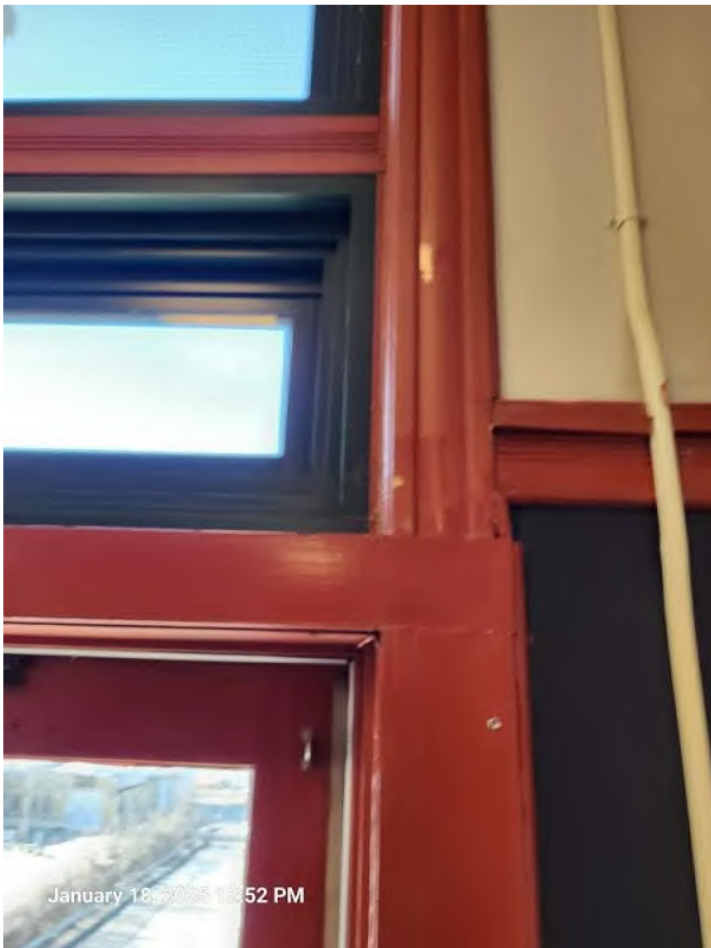
APPENDIX E: Ongoing Monitoring
