Lead Risk Assessment Report

1210 W Mineral St Milwaukee, WI 53204

Date of LIRA: 01/25/2025 Date of Report: 02/05/2025

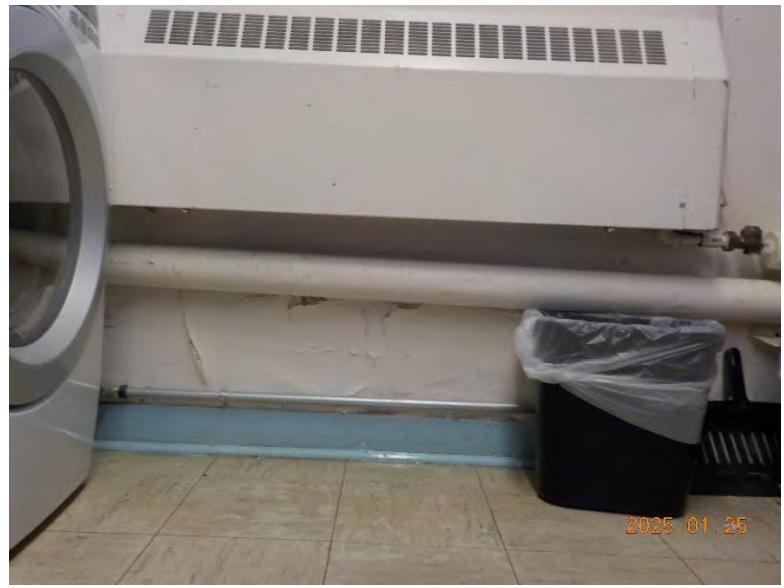
Room 008A – South Wall A deterioration (cracking/peeling)

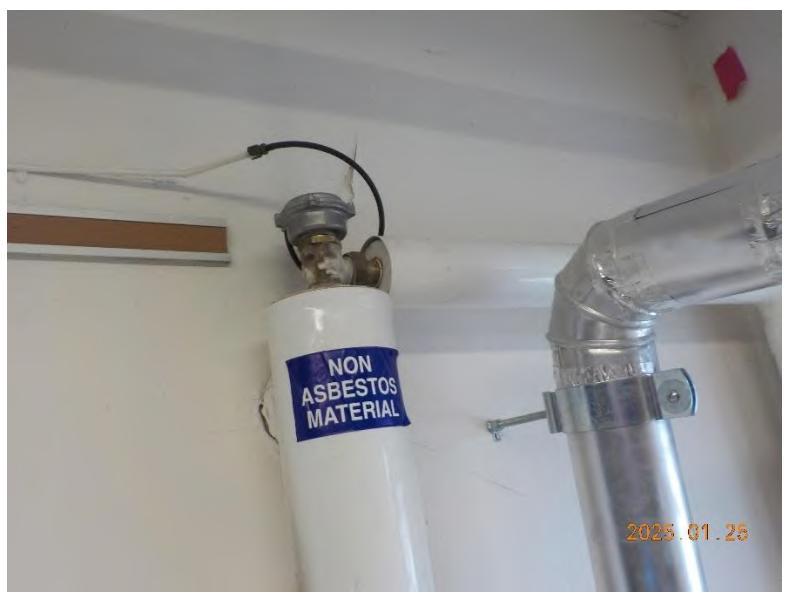
Rm 008A – East Wall D – deterioration (cracking)

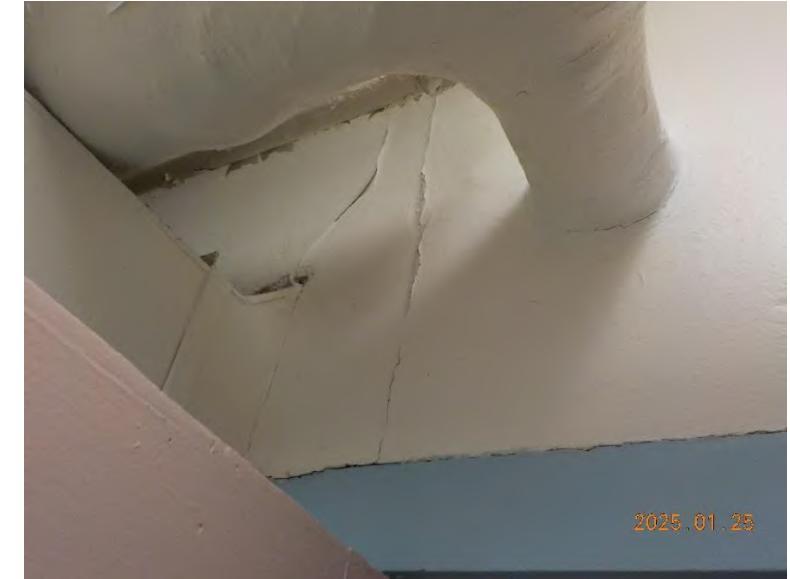
Rm 008A – North Wall C (cracking)

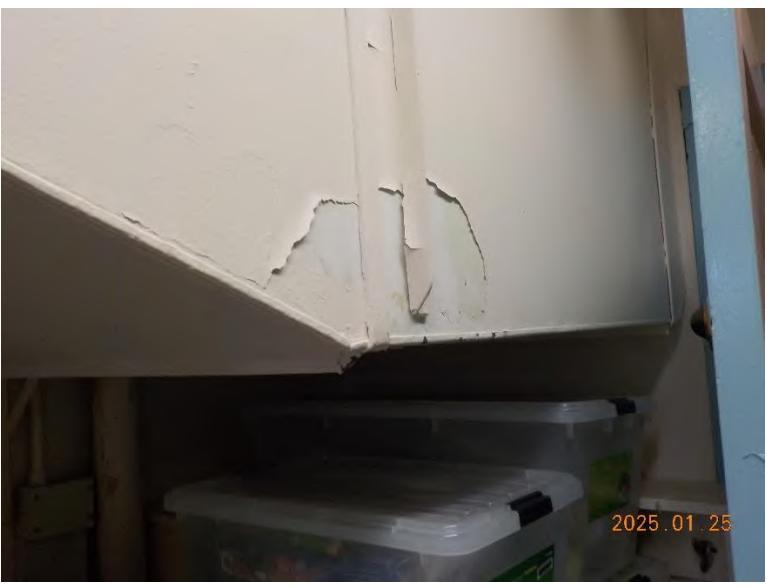
Rm 008A – HVAC duct wall B - deterioration (peeling/pickable)

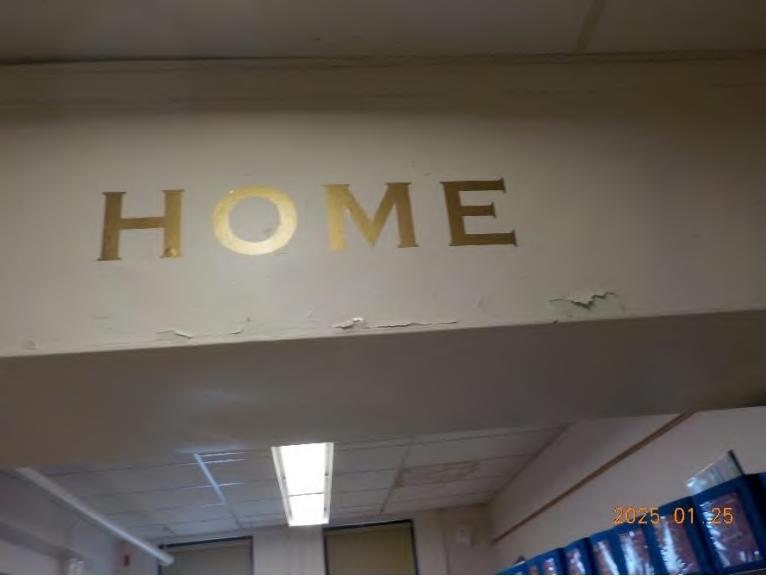
Rm 008A – HVAC duct (center of room) (peeling paint)

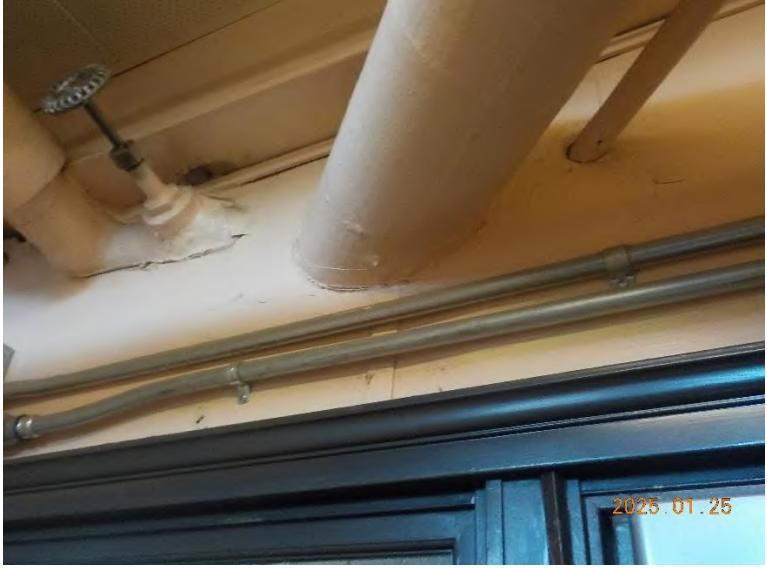
Stair 2-G1 – North wall deterioration over doors (cracking)

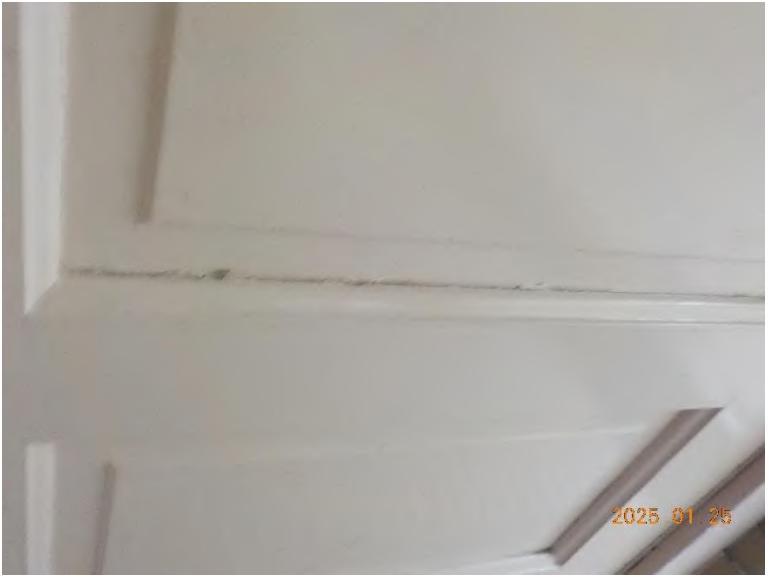
Room 002A – door-jamb & door (cracked/pickable paint)

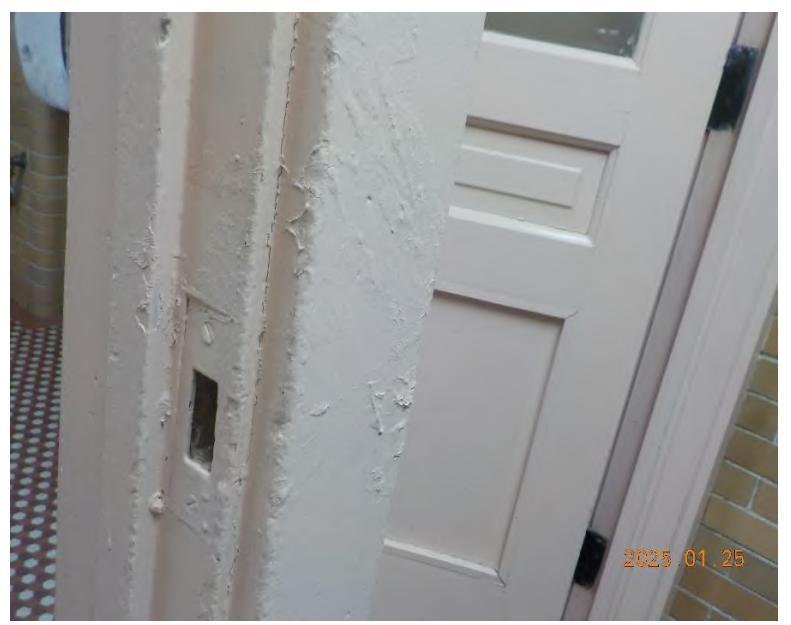
Boy's bathroom 002 door trim/jamb (pickable paint)

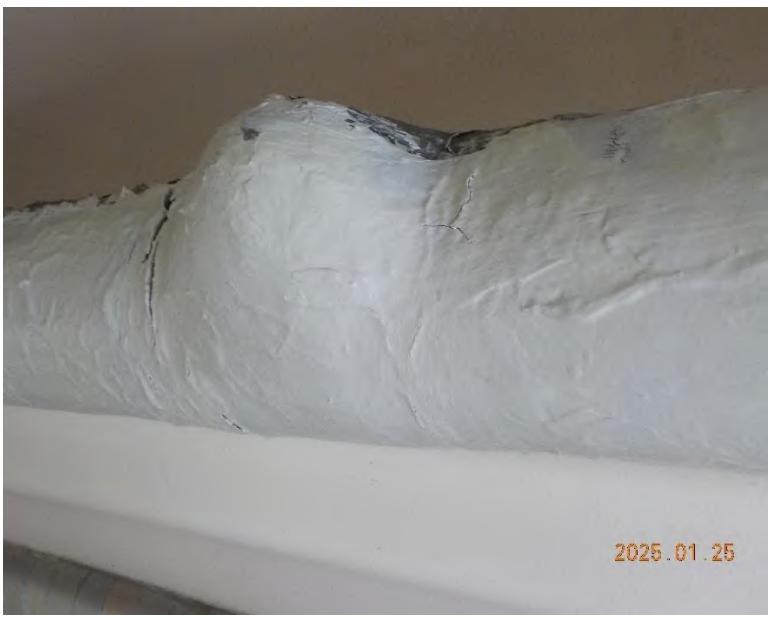
Rm 002 system pipe along ceiling by (east) wall D (cracking)

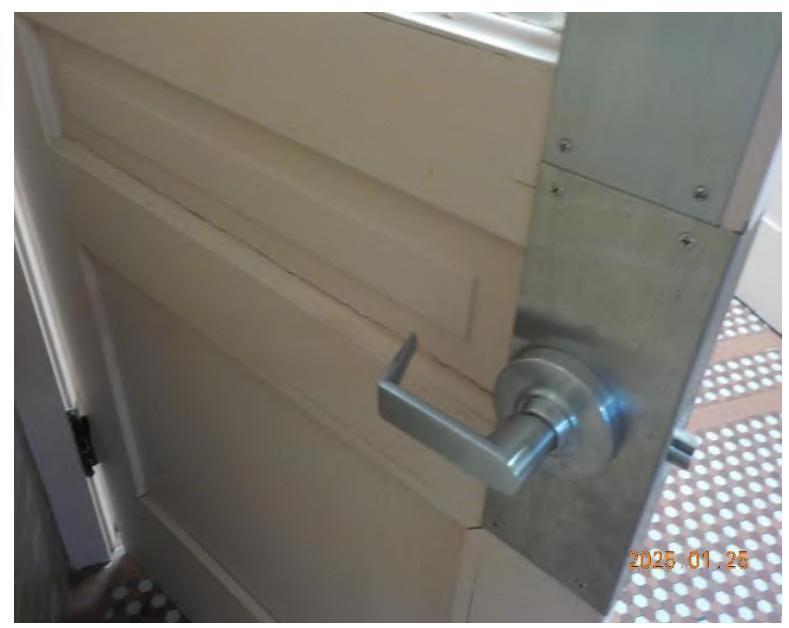
Bathroom 002 entrance doors show cracked/pickable paint along door panels, both sides of both doors

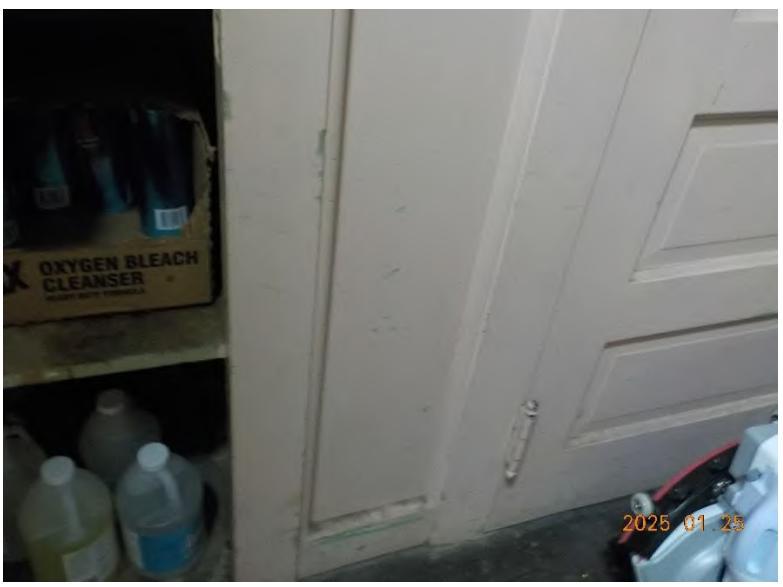
[Janitor's room] 007B -wall C cabinet frame deterioration (chipped)

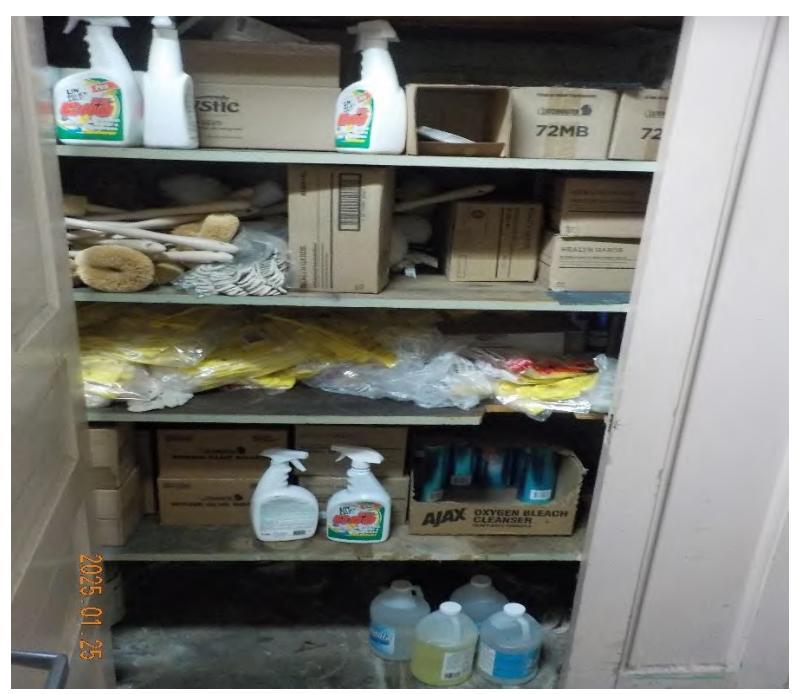
Wall C cabinet – shelves (all) – chipped paint

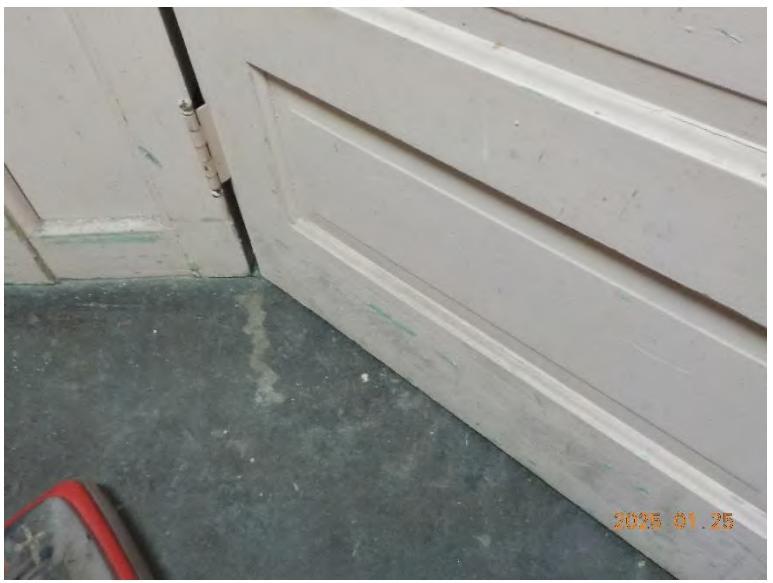
Wall C cabinet doors (all) – chipped/pickable paint

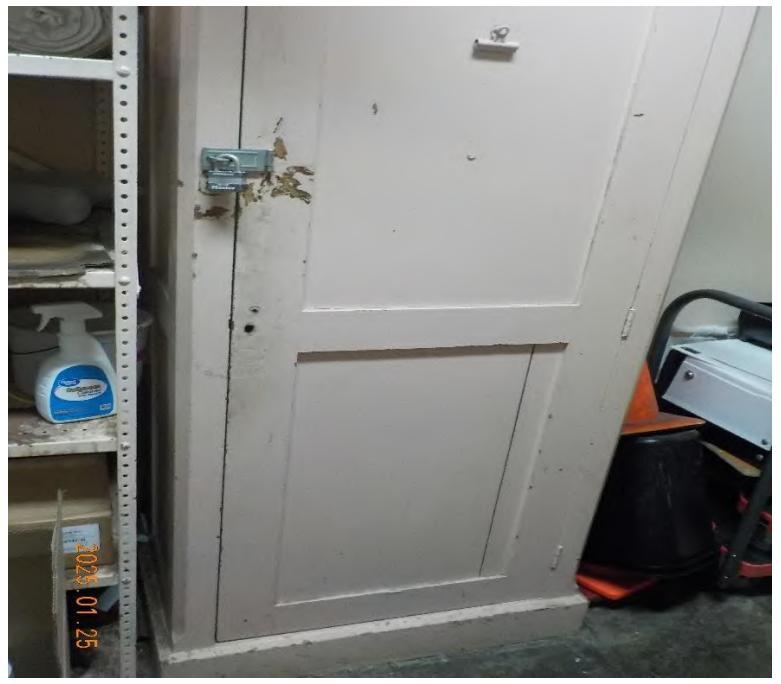
Wall A single cabinet – frame & door deterioration (chipped paint)

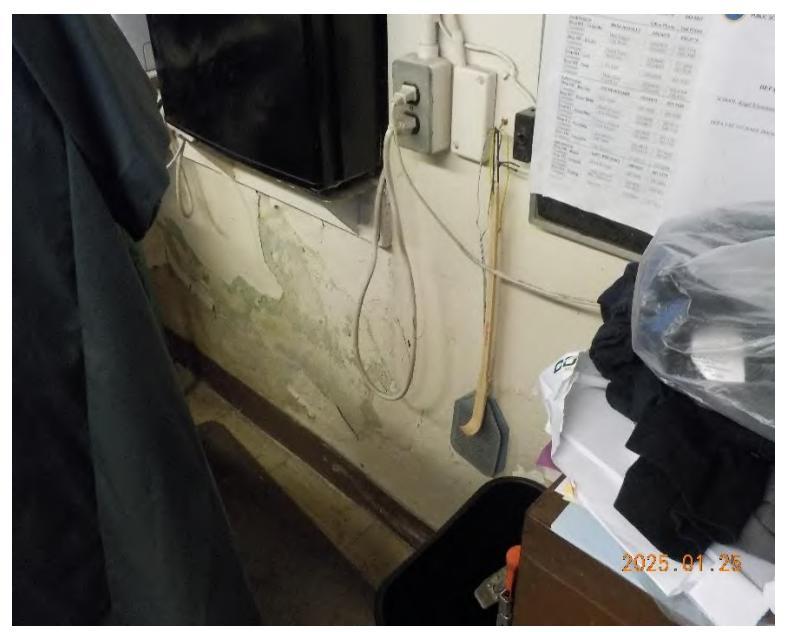
[Engineer's Office] Room 003 – West wall B deterioration (cracking/peeling paint)

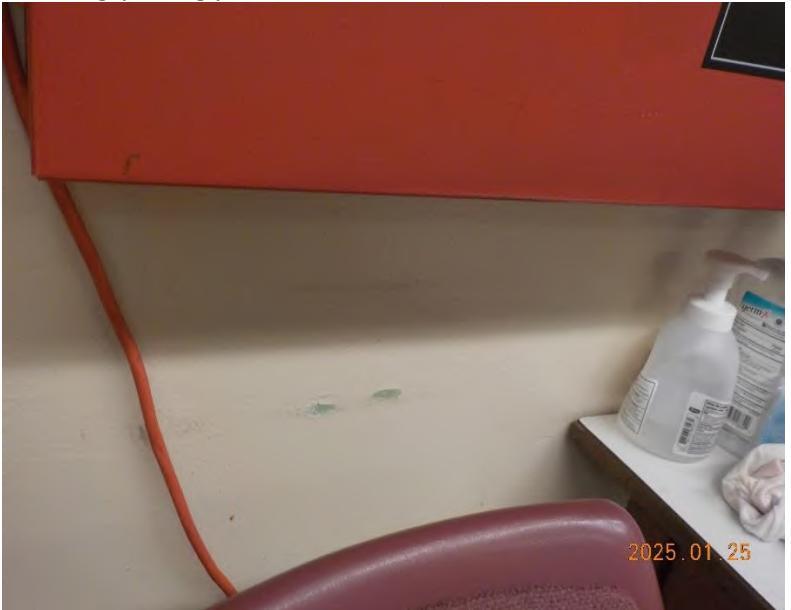
Room 003 East wall D (cracking & friction damage)

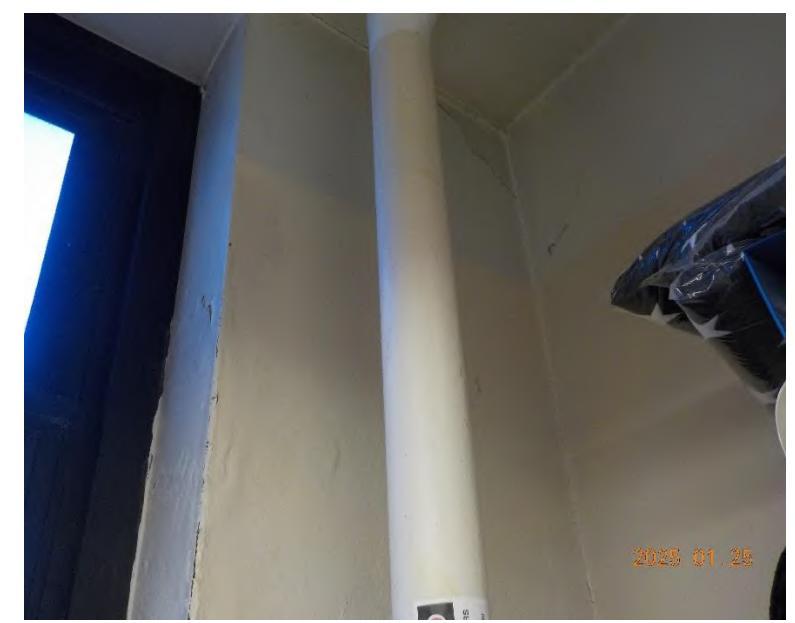
Rm 003 North wall C (cracking/chipping)

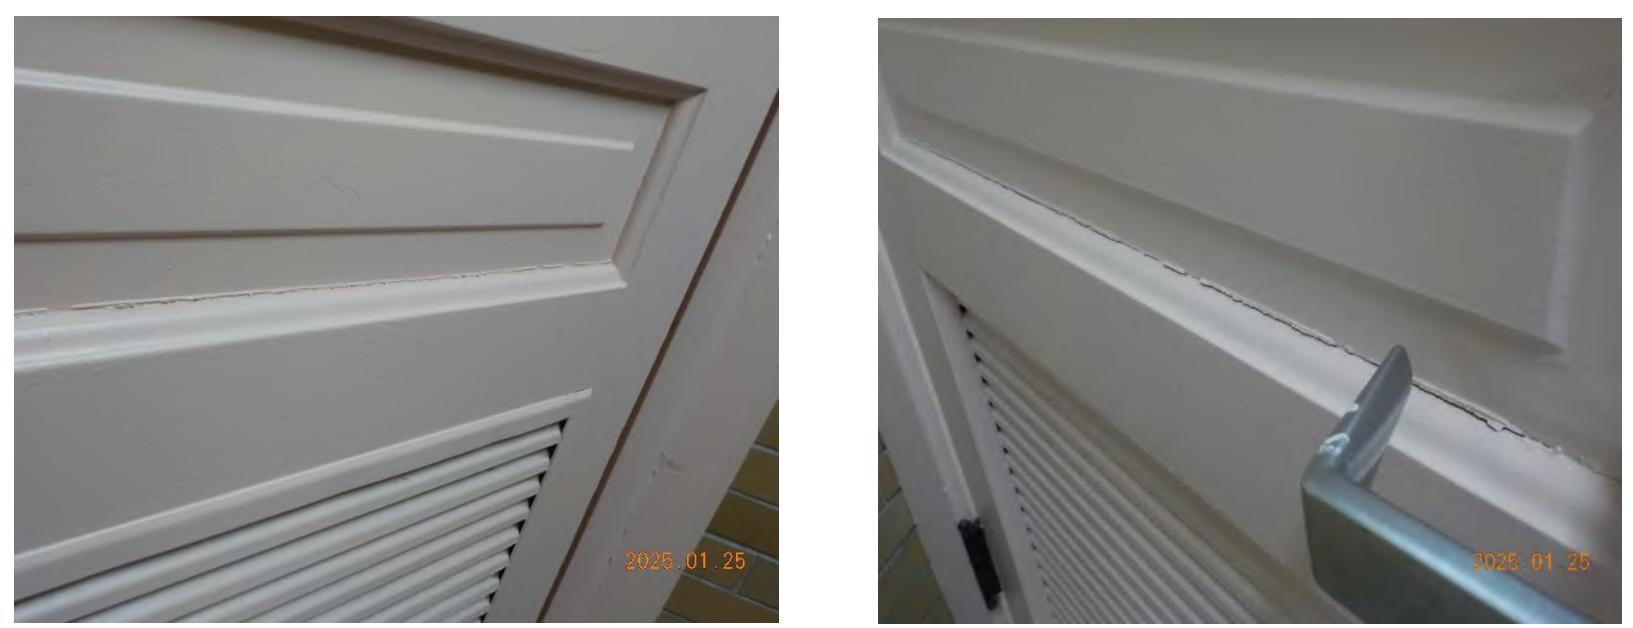
Girl's Bathroom 009 – both sides of right-side door from vestibule – (cracked/pickable paint deterioration)

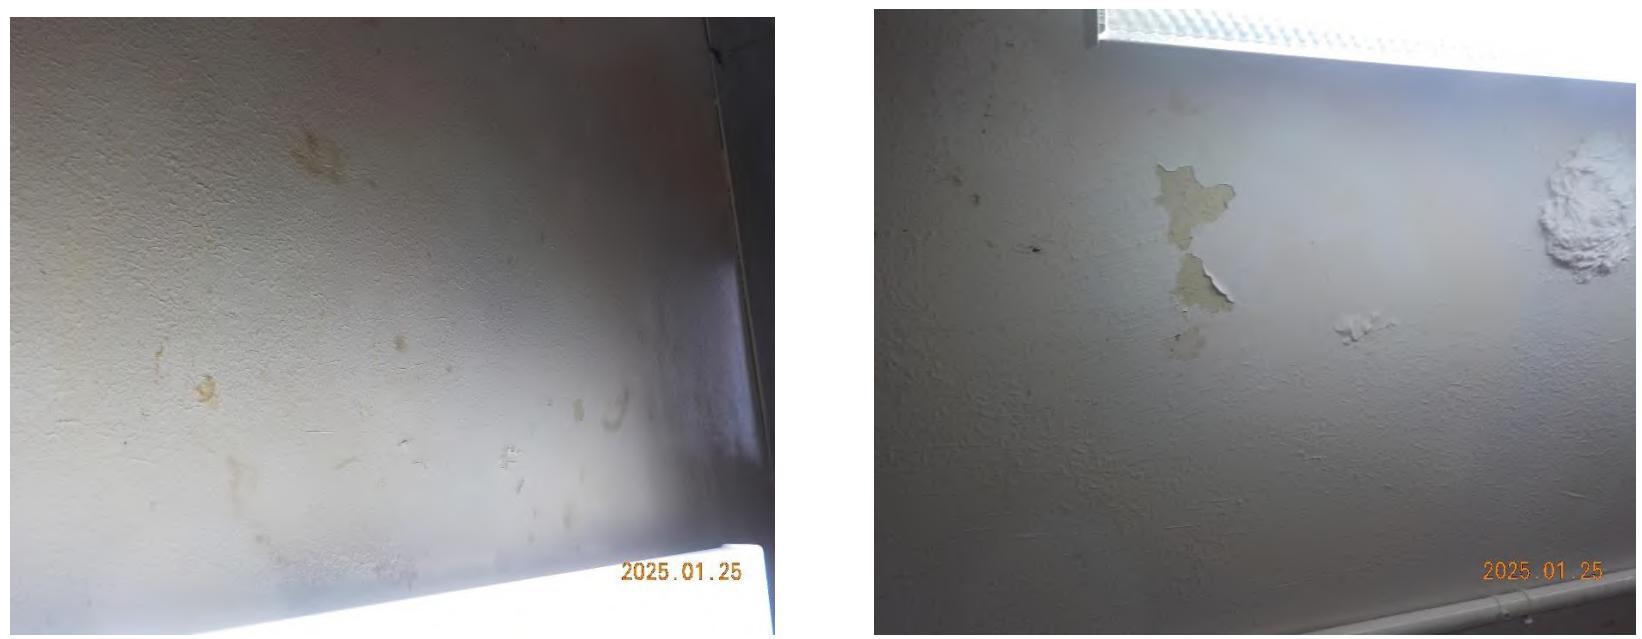
Girl's bathroom 009 - ceiling in sink area – deteriorated (peeling/chipped paint)

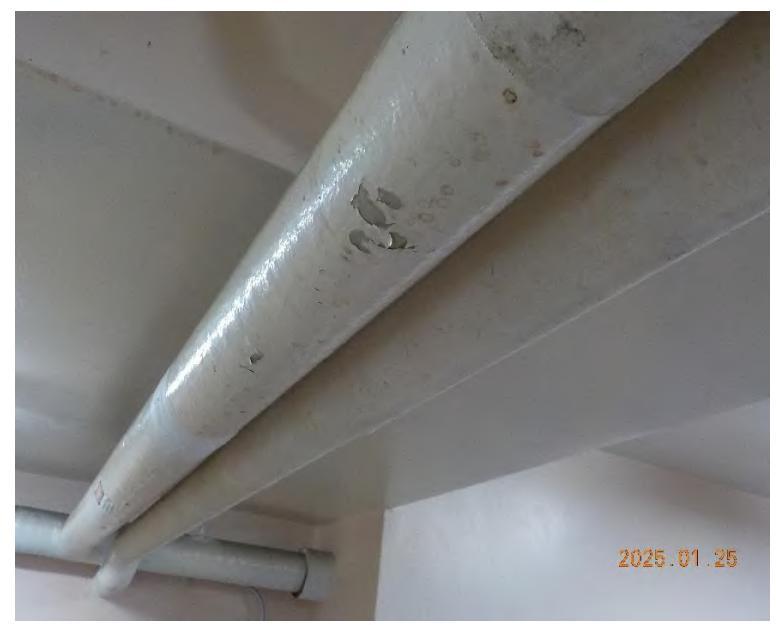
GB 009 – system pipe along ceiling in sink area (peeling paint)

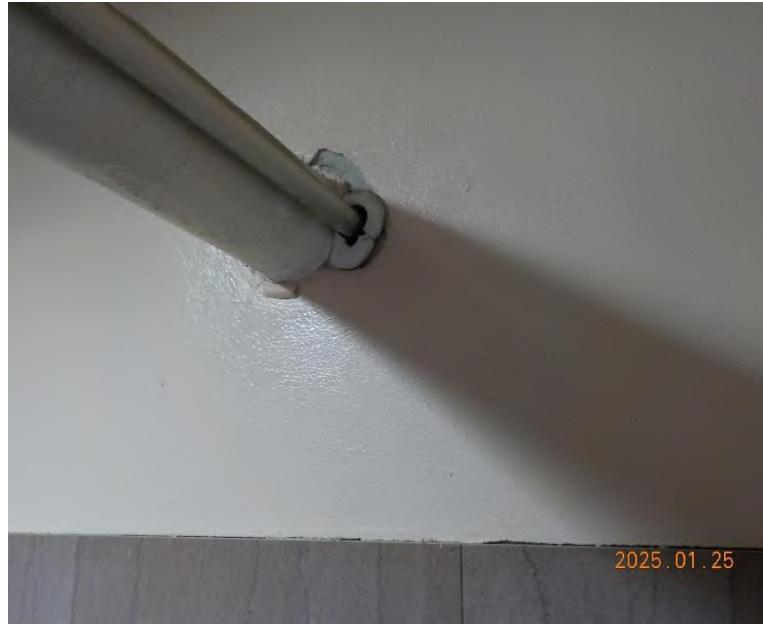
009 – West wall B of toilet area – (cracks/chipping around pipe)

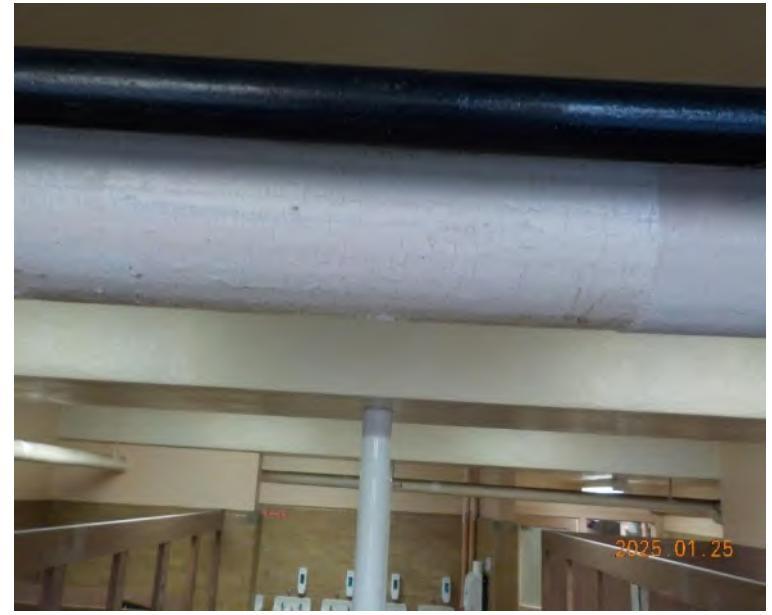
009 – system pipe by windows along outer wall C (cracking)

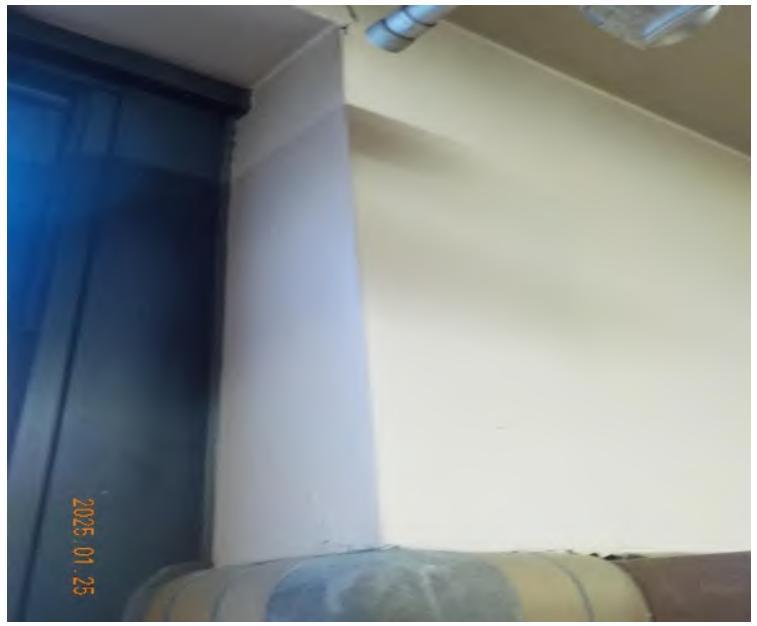
009 - North wall C by toilets (cracked/chipped paint)

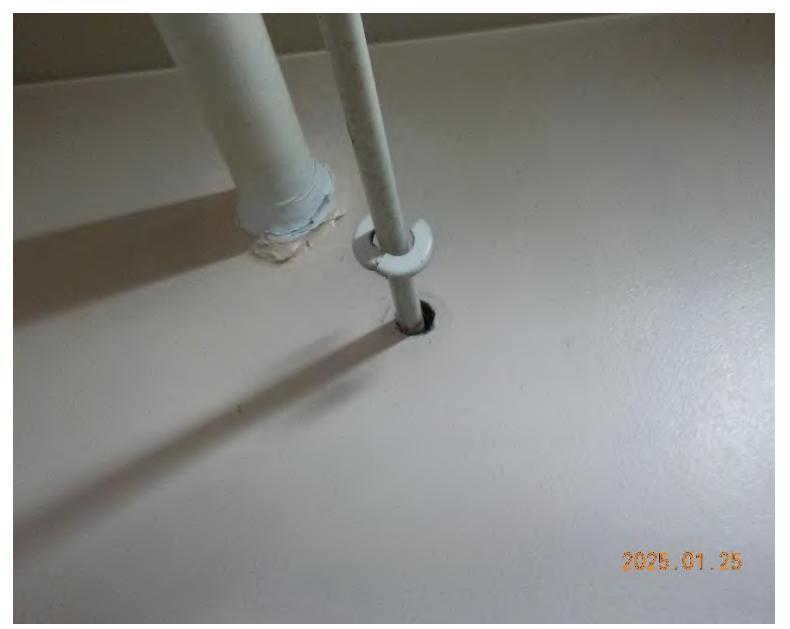
009 – East wall D – (cracked/chipped paint around pipes)

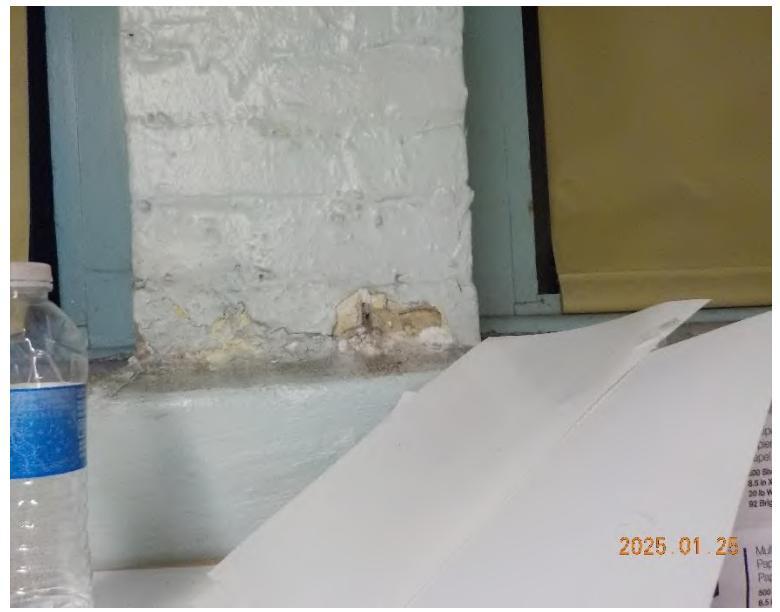
Room 006A – North wall C deterioration (cracked/chipped paint)

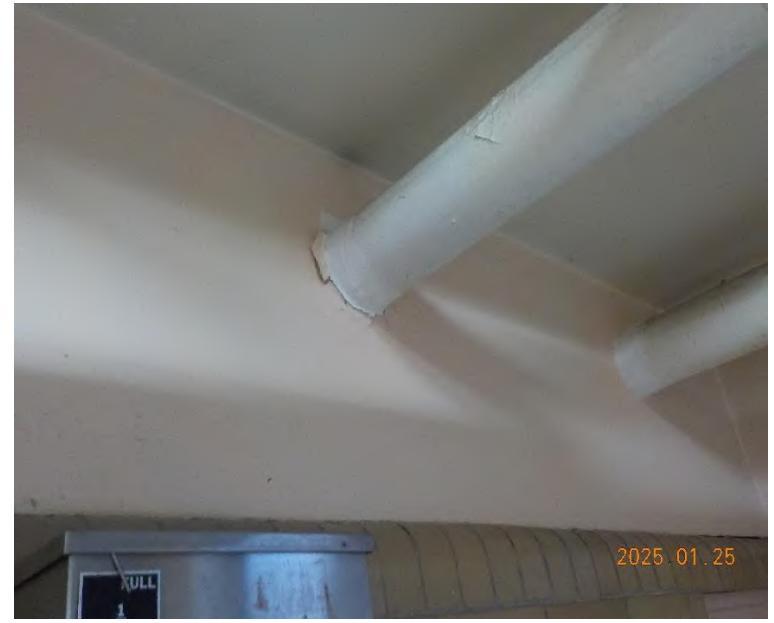
009 – North wall C over sinks – (cracked paint around pipes)

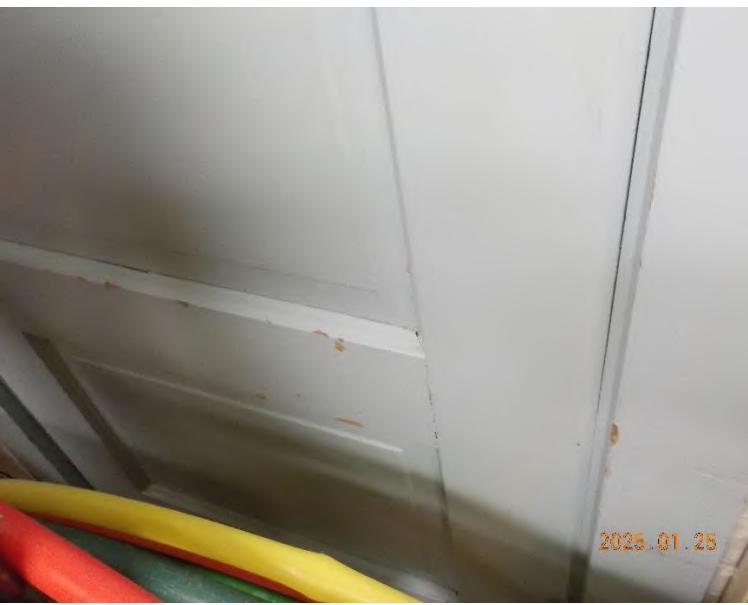
Rm 006A – door-trim & door to Rm 006 (chipped paint by hula-hoop storage)
