Coon Creek Watershed

DRAFT Plan-PEIS Meeting
January 18, 2024

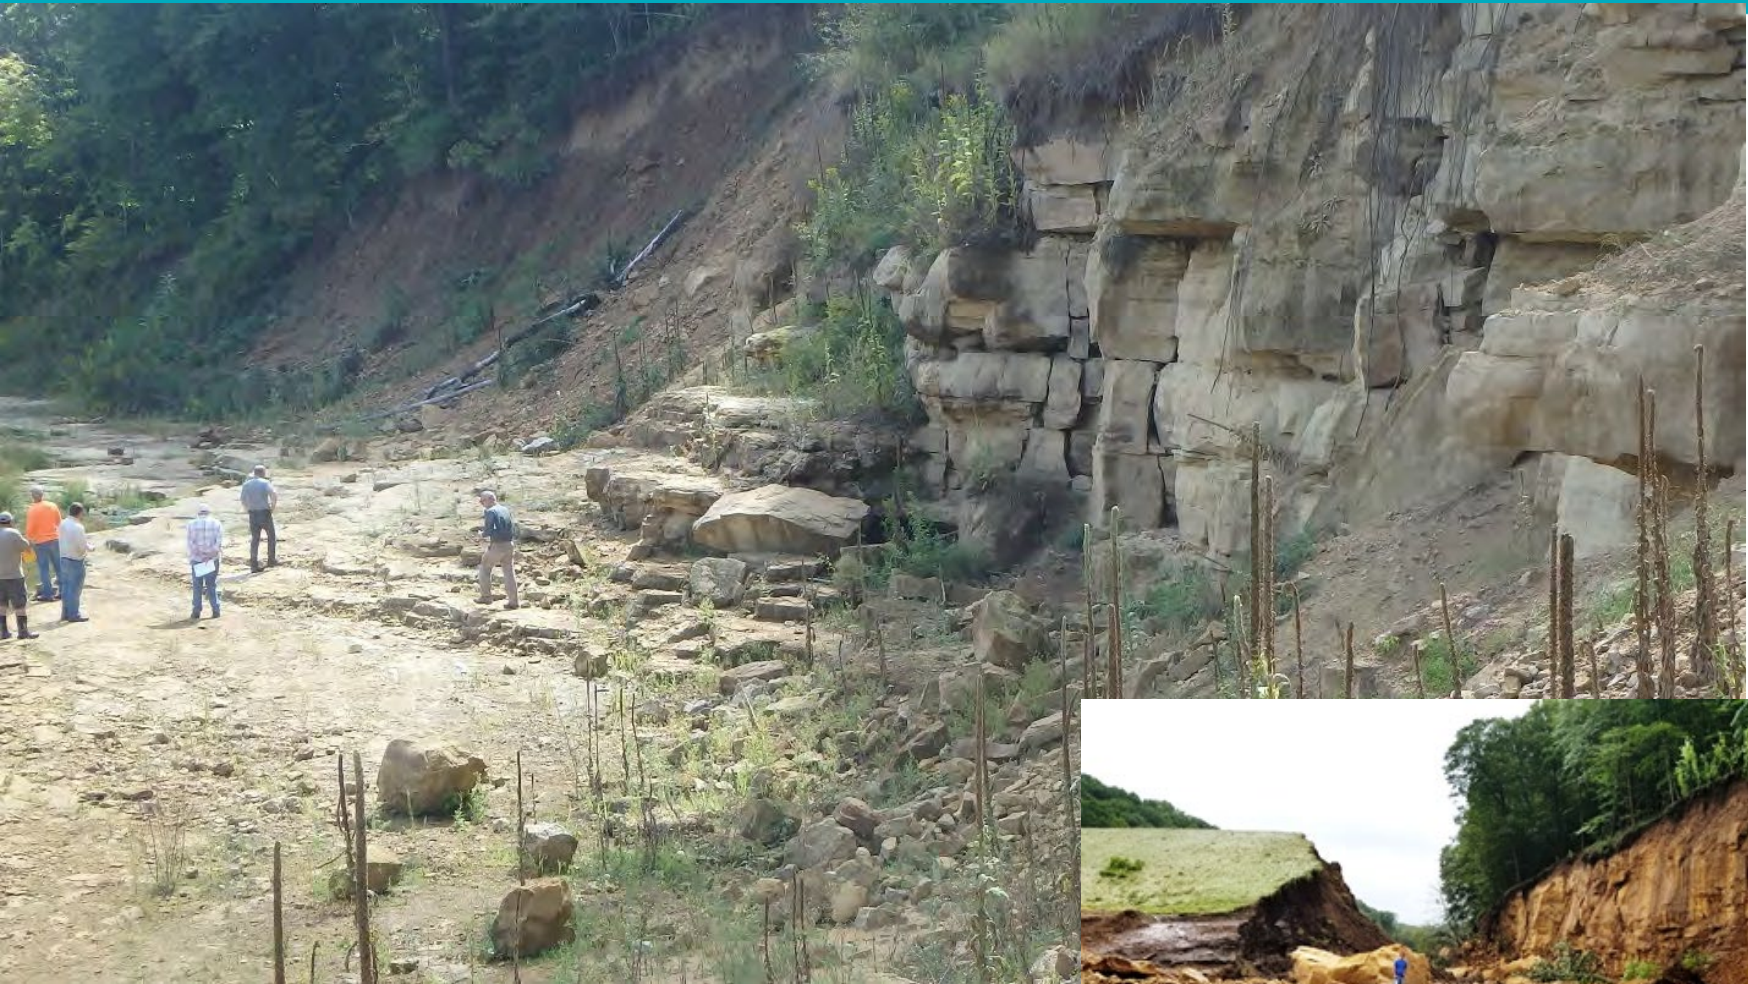
Geologic stress fractures exist in sandstone foundation along the abutments and valley bottom.

Cracks create preferential seepage paths under and around the dam under full reservoir conditions. These cracks cause internal erosion which is primary mode of failure:

Fractured sandstone abutments
exposed after dam failure

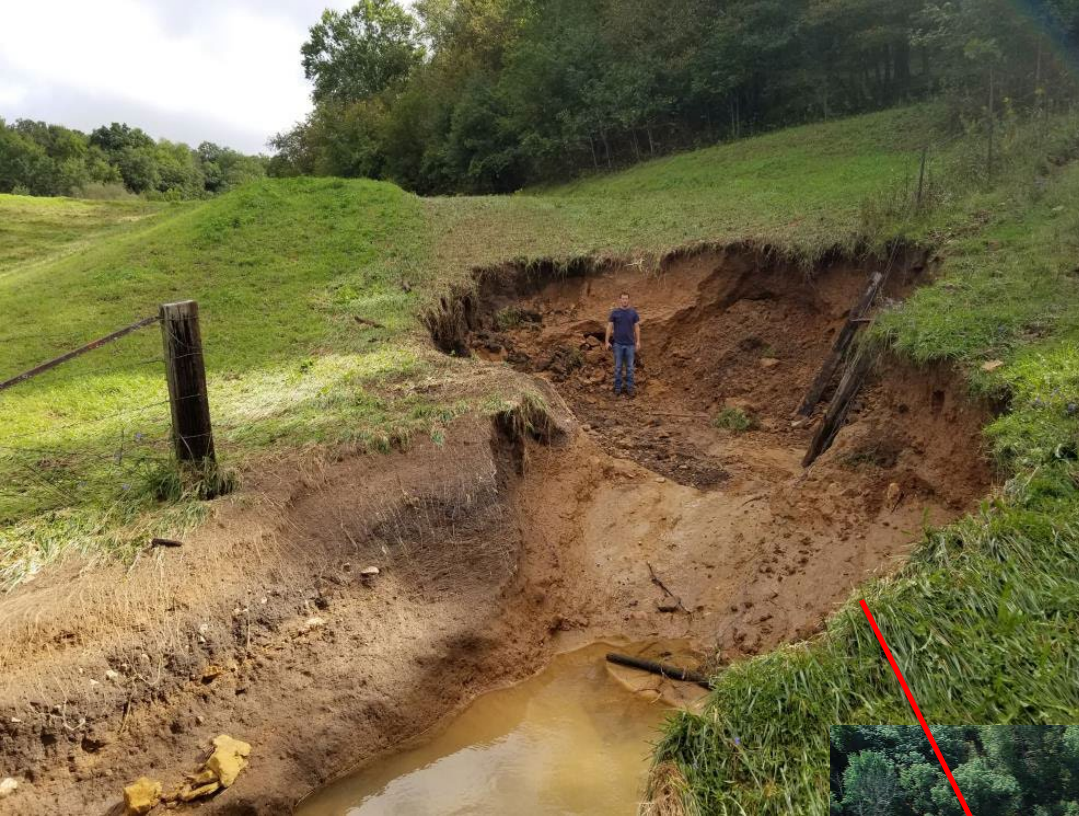
Auxiliary Spillway Integrity
= Resistance to breach

Remedies:

- concrete cutoff walls
- or concrete chute spillways

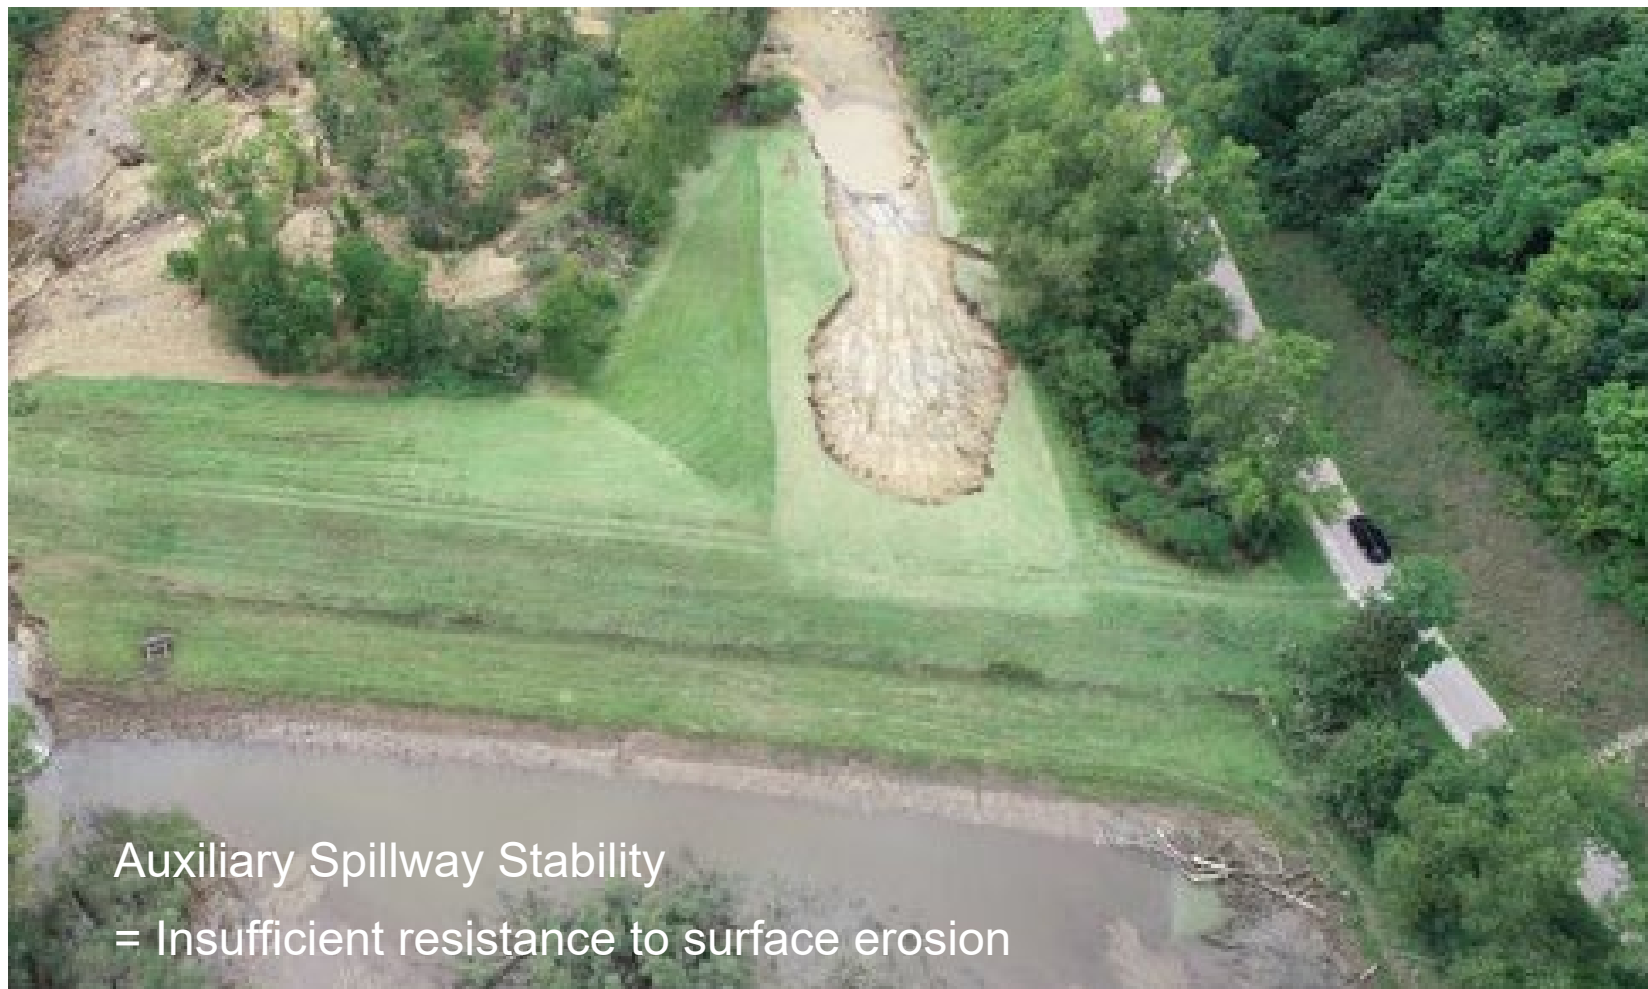
Auxiliary Spillway Stability
= Insufficient resistance to surface erosion

Remedies:

- Increased width
- Erosion resistant soils

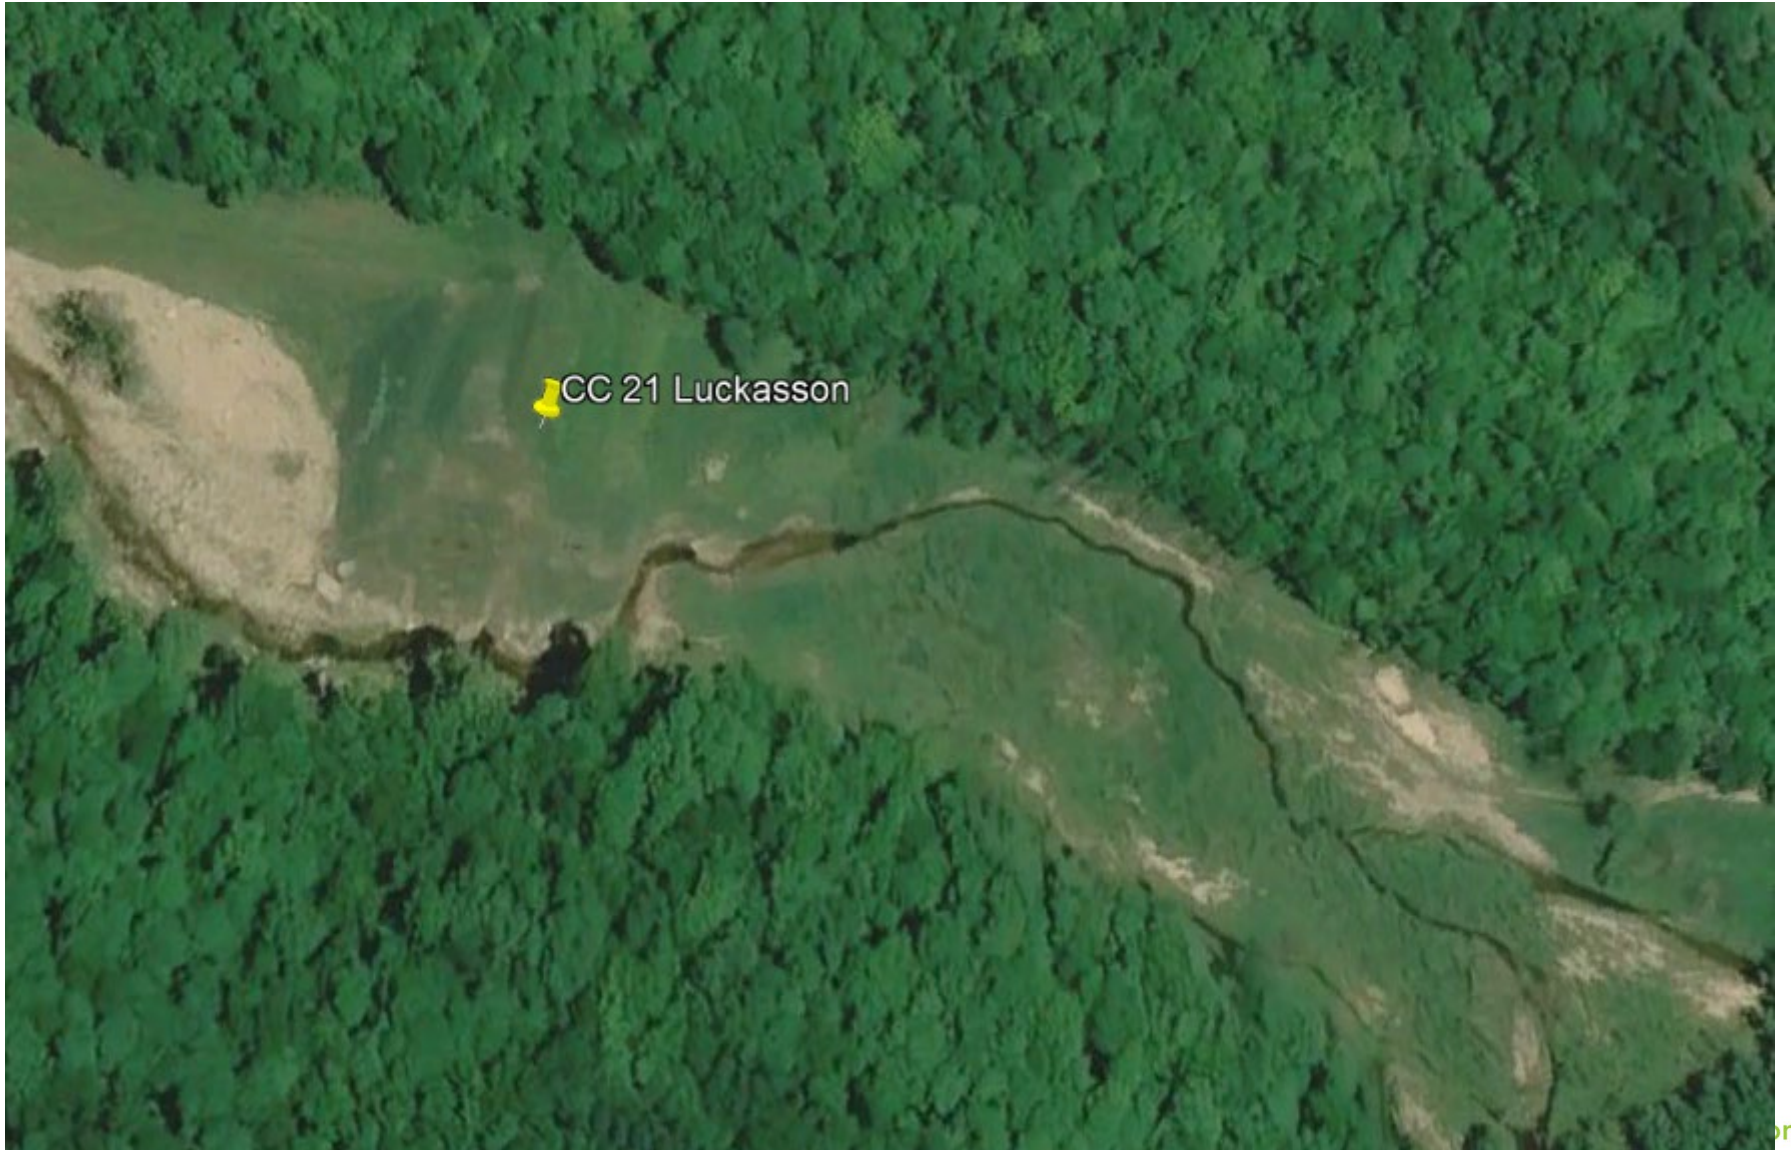
Breached dam shows channelization in the sediment pool

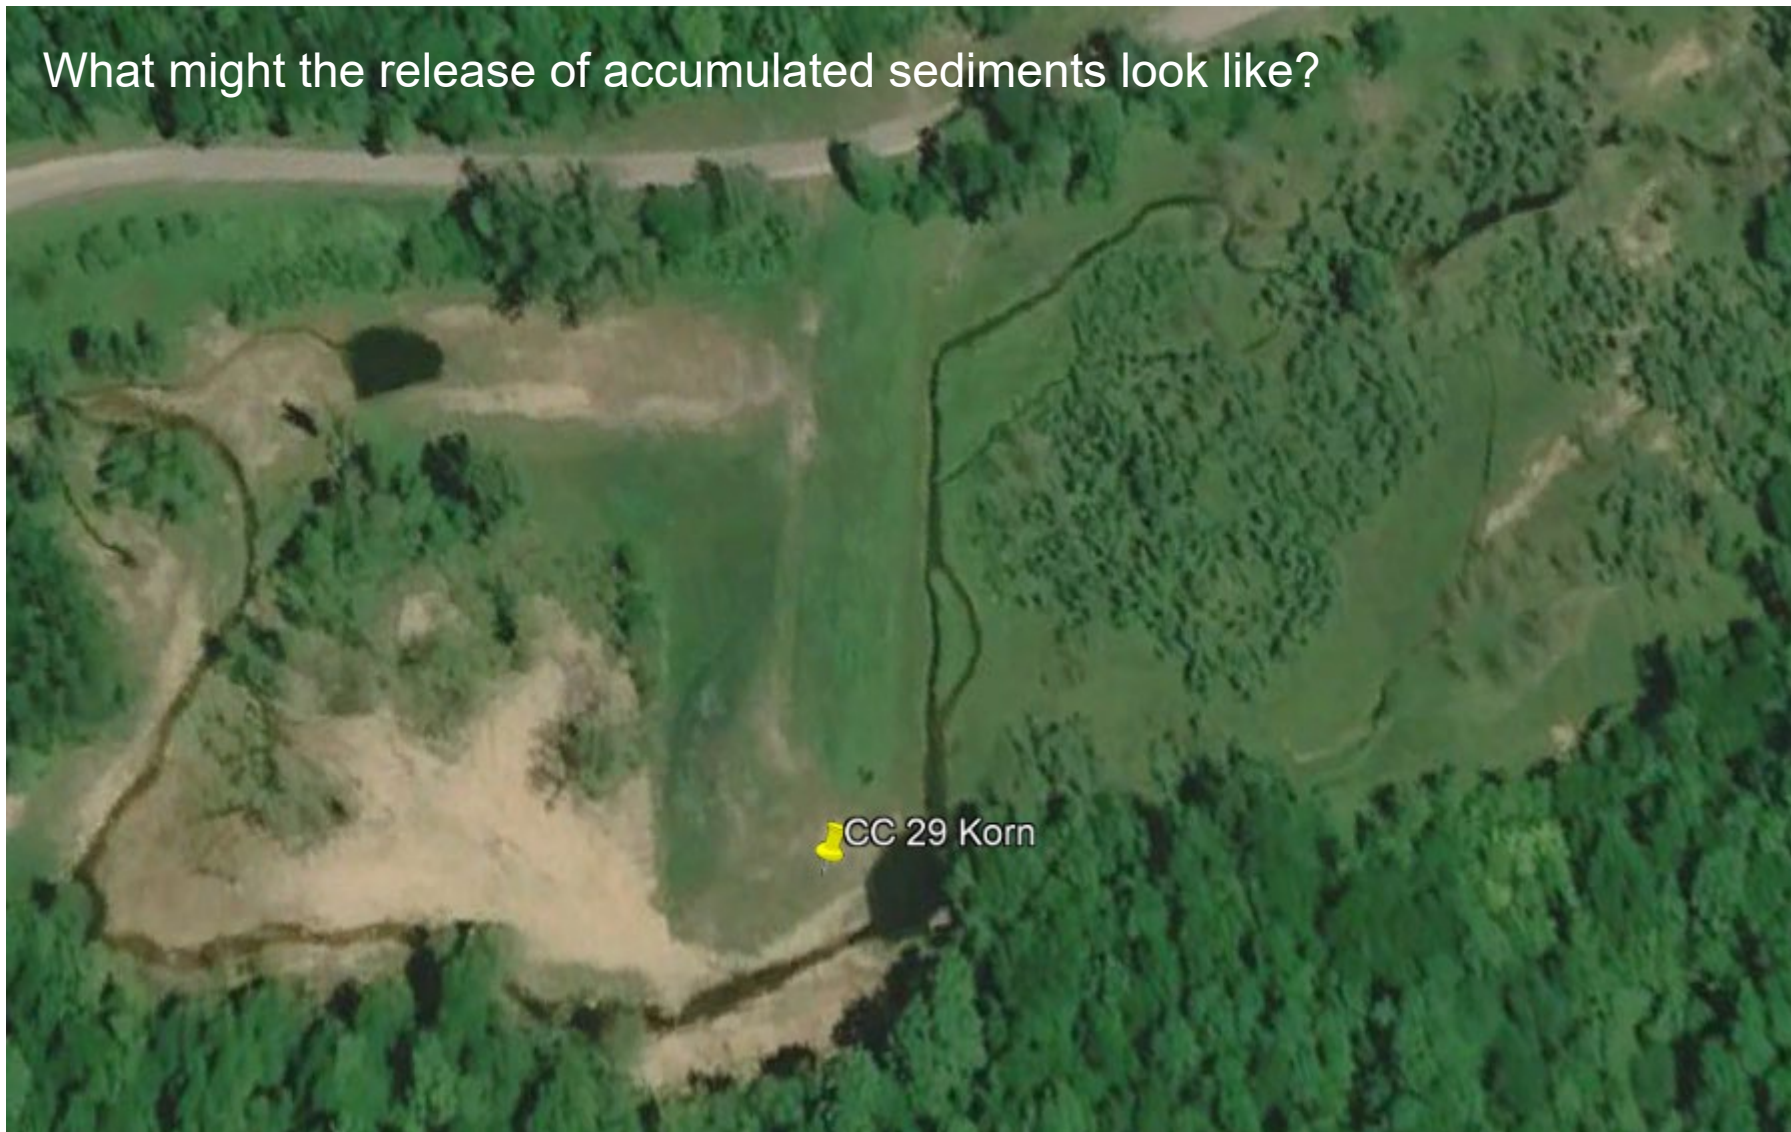
Breached dam shows channelization in the sediment pool

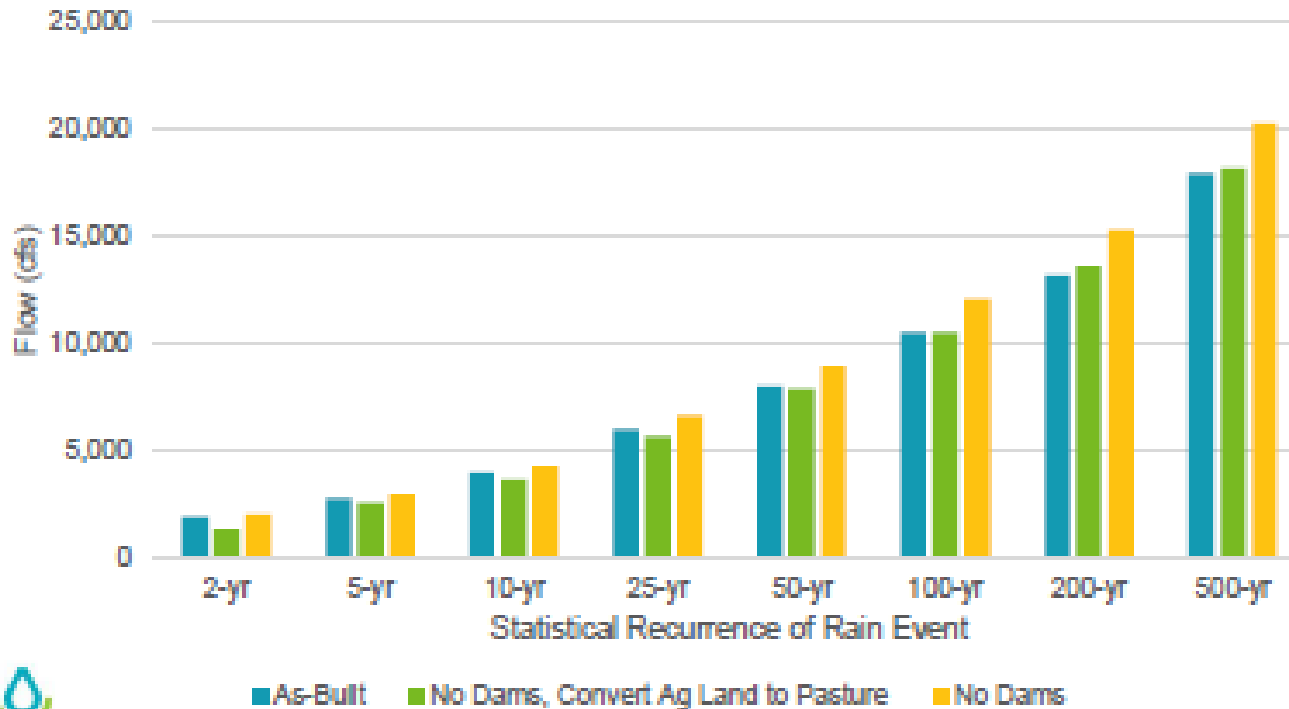
- **Peak Flow on Coon Creek at Coon Valley**

Flow Scenarios during Statistical Rain Events
